# **OPERATING EXPERIENCE WEEKLY SUMMARY**

**Office of Nuclear and Facility Safety**

**October 23 - October 29, 1998**

**Summary 98-43**

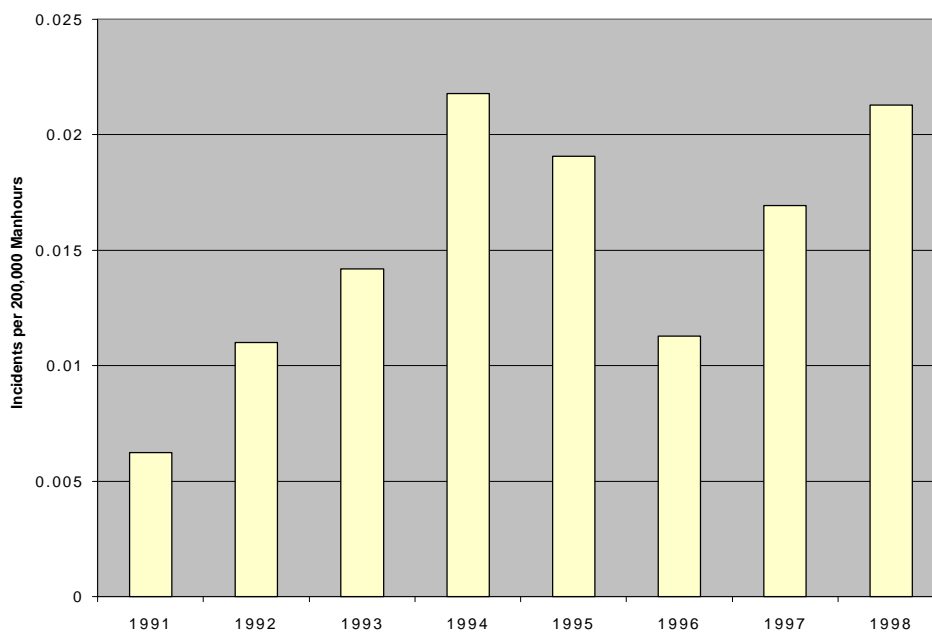
OEAF engineers searched the ORPS database<sup>1</sup> for occurrences involving inadequate lockouts/tagouts and identified 197 occurrences. Facility managers cited personnel error as the direct cause for 165, or 84 percent, of these occurrences. Procedure not used or used incorrectly accounted for 67 percent of personnel errors, and inattention to detail accounted for 22 percent. Figure 1-1 illustrates the annual frequency of lockout/tagout events systemwide normalized to manhours. Data for 1998 is extrapolated. The data shows a steady increase in frequency since 1996, following a decline from 1994 to 1996.

**Figure 1-1. Annual Distribution of Lockout /Tagout Events**

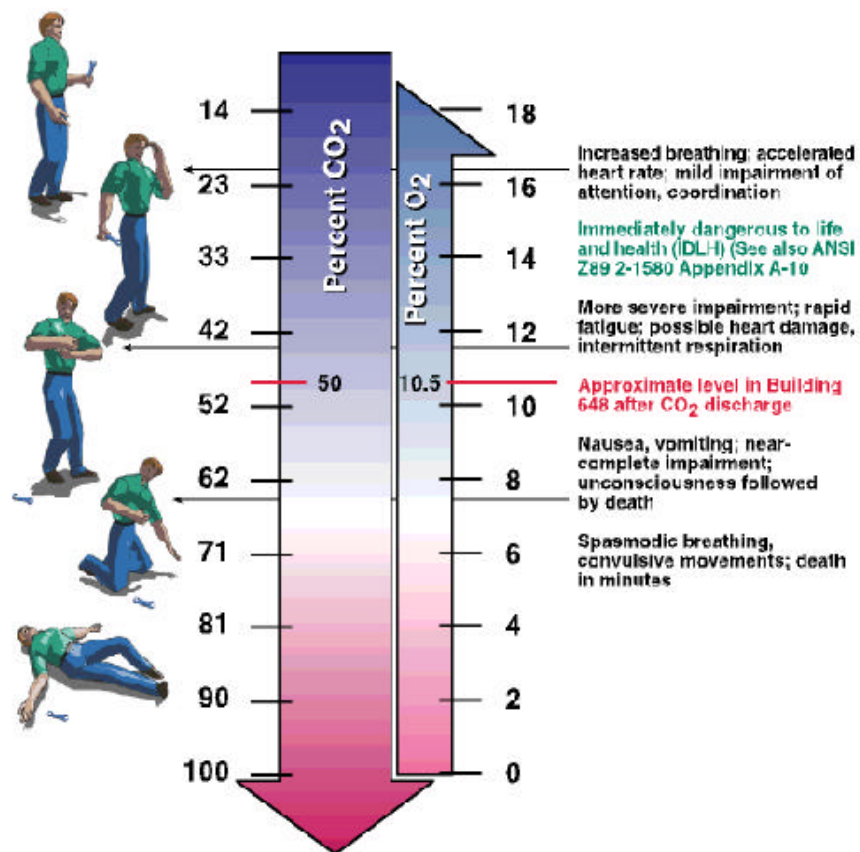
The use of CO<sub>2</sub> as an extinguishing agent does not come without risks. The concentration of CO<sub>2</sub> needed to extinguish fires is many times greater than the lethal concentration. Investigators determined that the percentage of CO<sub>2</sub> in the building following the discharge was approximately 50 percent. This is well above the 30 percent minimum concentration necessary for fire protection and was potentially lethal to the occupants. At 50 percent CO<sub>2</sub>, the oxygen levels in the building would be approximately 10.5 percent, well below that needed to sustain life. Once discharge begins, evacuation becomes difficult because of reduced visibility, loud noise, and disorientation from physiological effects. Figure 1-1 shows the physiological effects of CO<sub>2</sub> exposure.

Figure 1-1. Physiological Effects of CO<sub>2</sub> Exposure
